**Flood Control Project Maintenance
Levee Inspections**
LMA District Cover Sheet
Spring 2018 Levee Inspection Results

Sutter Maintenance Yard Murphy Slough at M&T Ranch

Levee Inspection Report By Mile - Spring 2018

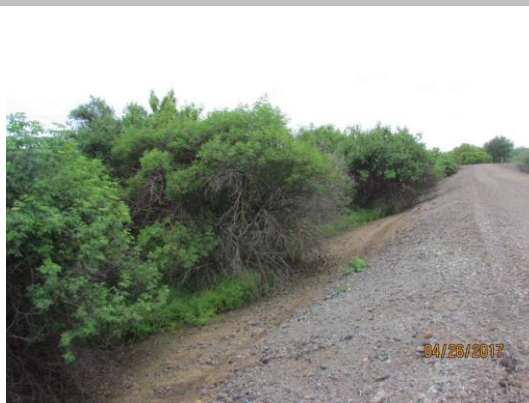
Photo 1 of 1 : SP_2018_ST0014_372_4_20180305_00002.jpg

LM Start	0.00	Rating **	M	Issue No.	4
LM End	0.09	Issue Type +	Ma	Location *	LS
Category	Earthen Levee			GPS Latitude/Longitude	
				Start	End
Item	Vegetation			39.667708 °	39.666983 °
				-121.959817 °	-121.960997 °
DWR ID	DWR_NA0014_01_s _ 2012_4				
Comment Code					
V4 : Elderberries are blocking visibility and flood fight capability.					
Inspector Comment

View of the elderberries along the landside toe.

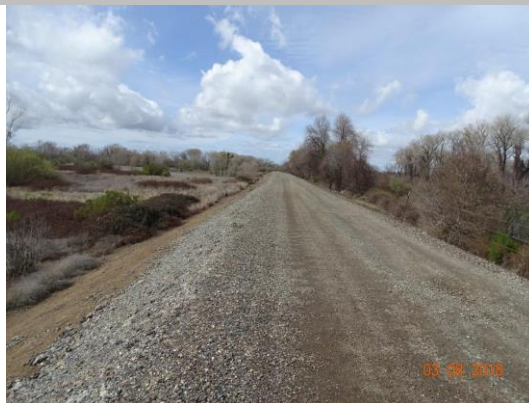
Photo 1 of 1 : SP_2018_ST0014_372_5_20180312_00003.jpg

LM Start	0.11	Rating **	A	Issue No.	5
LM End	0.83	Issue Type +	Ma	Location *	LS
Category	Earthen Levee			GPS Latitude/Longitude	
				Start	End
Item	Vegetation			39.666822 °	39.670685 °
				-121.960913 °	-121.970463 °
DWR ID	DWR_ST0014_01_s_2018_5				
Comment Code					
V1 : Control annual grass and weeds on the levee slopes and easements.					
Inspector Comment					
There is no vegetation on the levee slope.

View of the both levee slopes with no vegetation.
